**MEMORANDUM OF AGREEMENT
AMONG
THE FEDERAL TRANSIT ADMINISTRATION,
THE DISTRICT OF COLUMBIA STATE HISTORIC PRESERVATION OFFICER
AND
THE WASHINGTON METROPOLITAN AREA TRANSIT AUTHORITY
REGARDING
THE NORTHERN BUS GARAGE RENOVATION PROJECT IN
WASHINGTON, DC**

WMATA NORTHERN BUS GARAGE: IDENTIFICATION OF HISTORIC FABRIC REPORT

Informing the Treatment of the Existing Structure and
Design of the Replacement Bus Garage

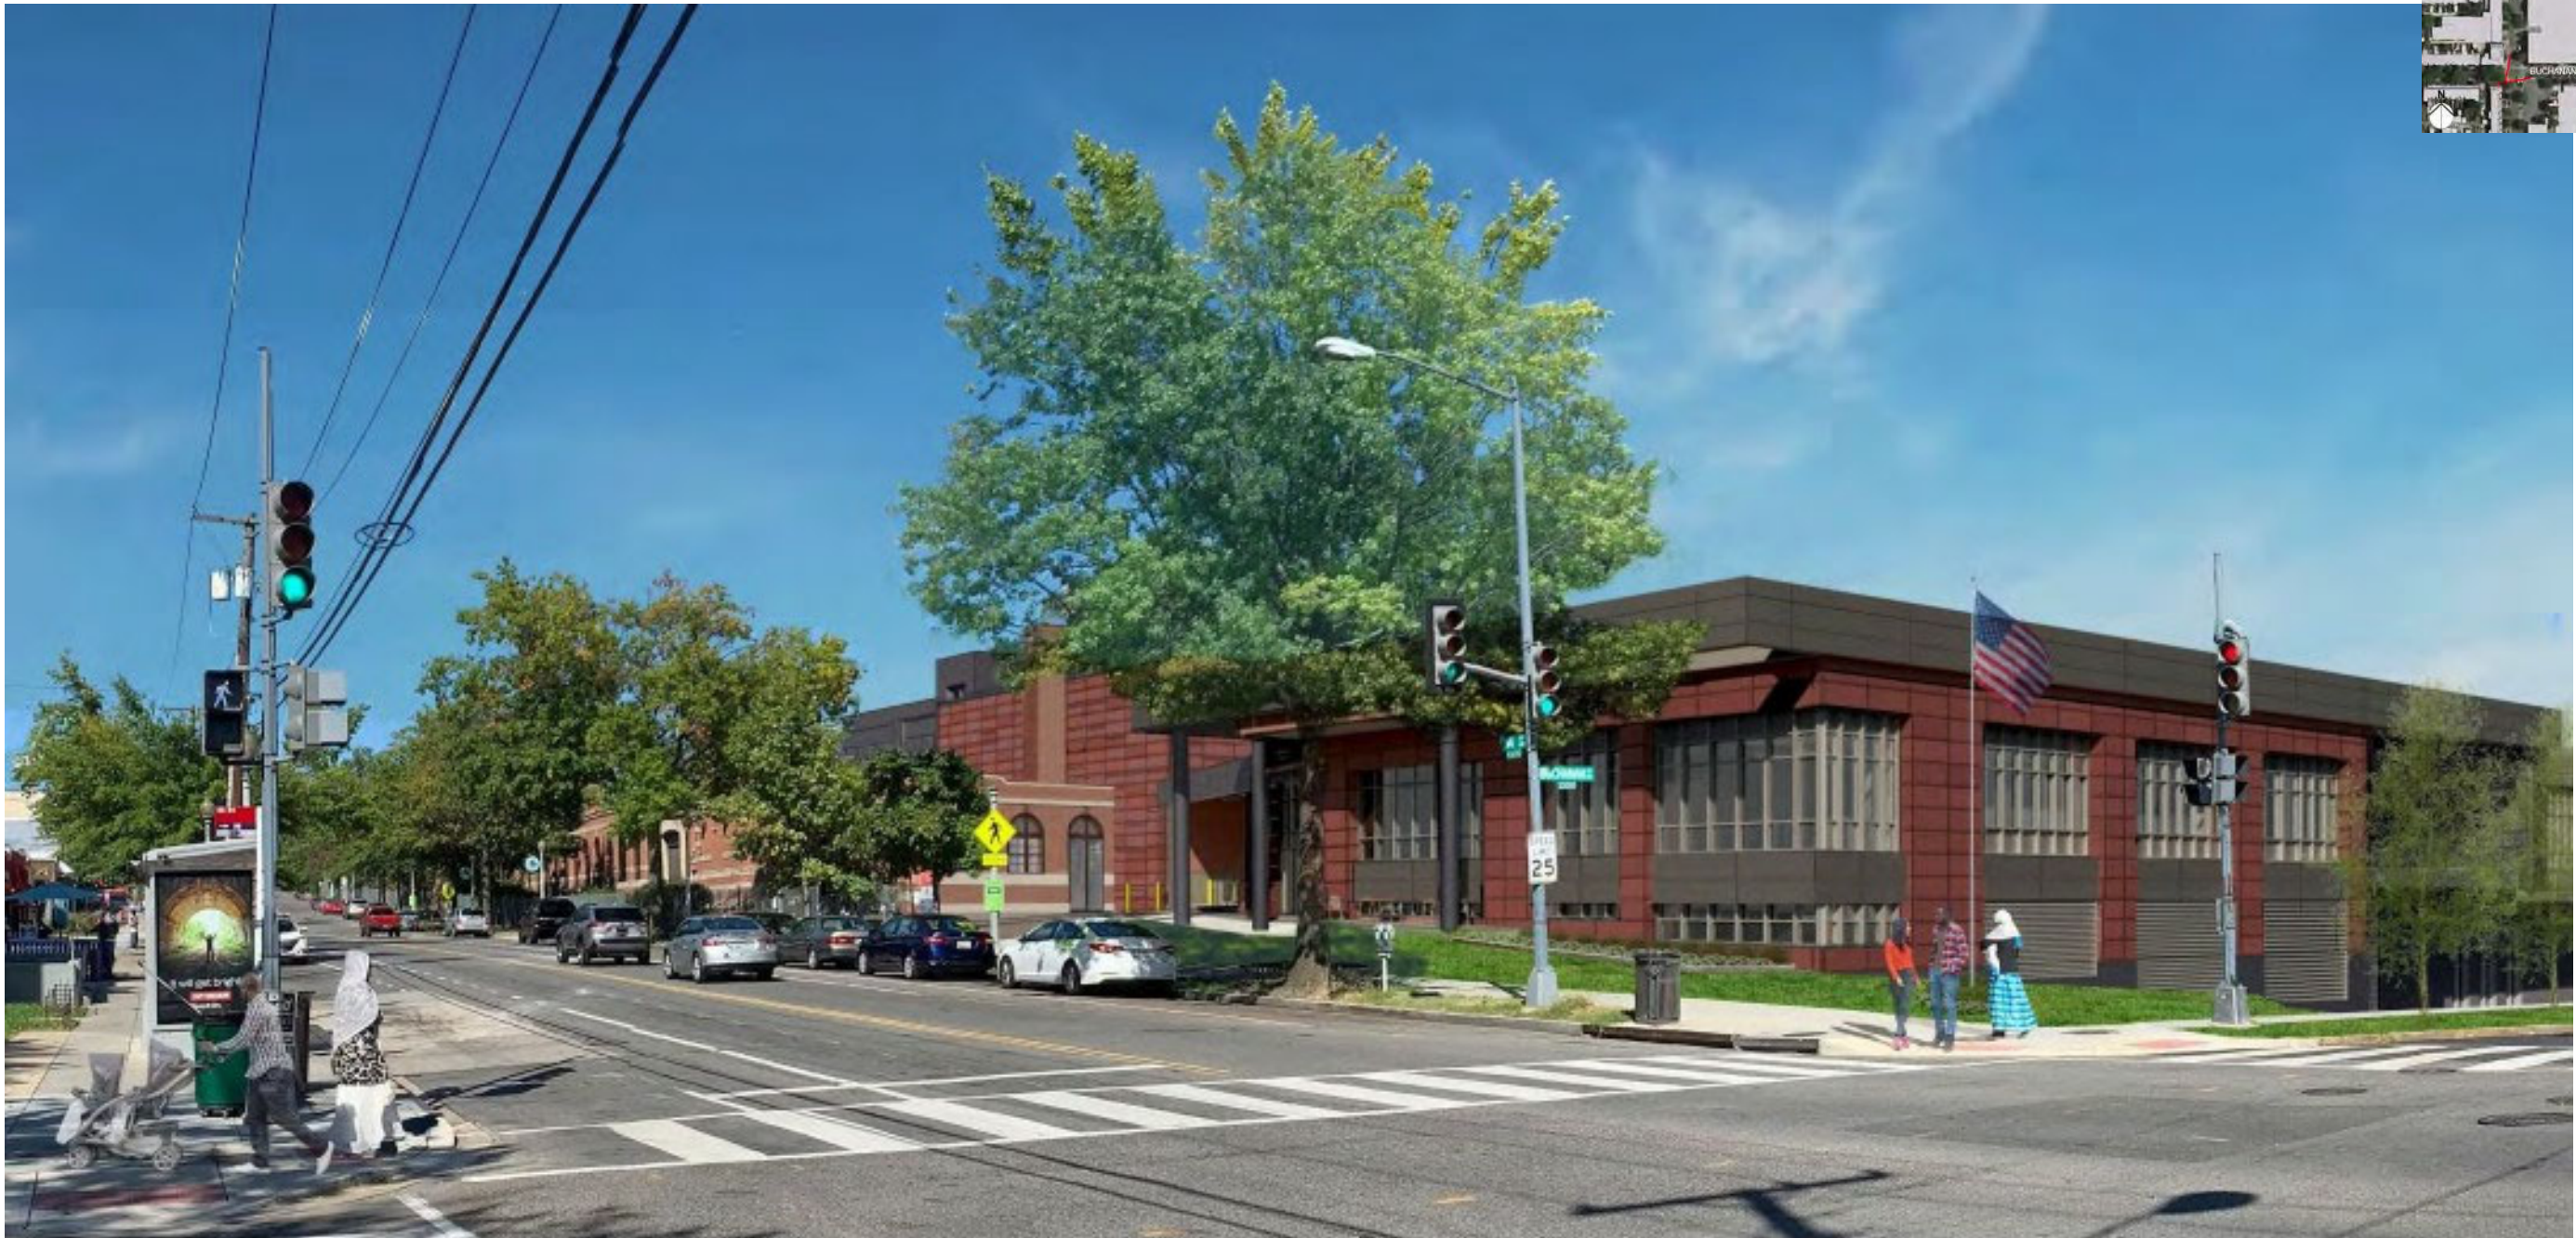
SOUTHWEST VIEW LOOKING NORTHEAST ALONG 14TH STREET

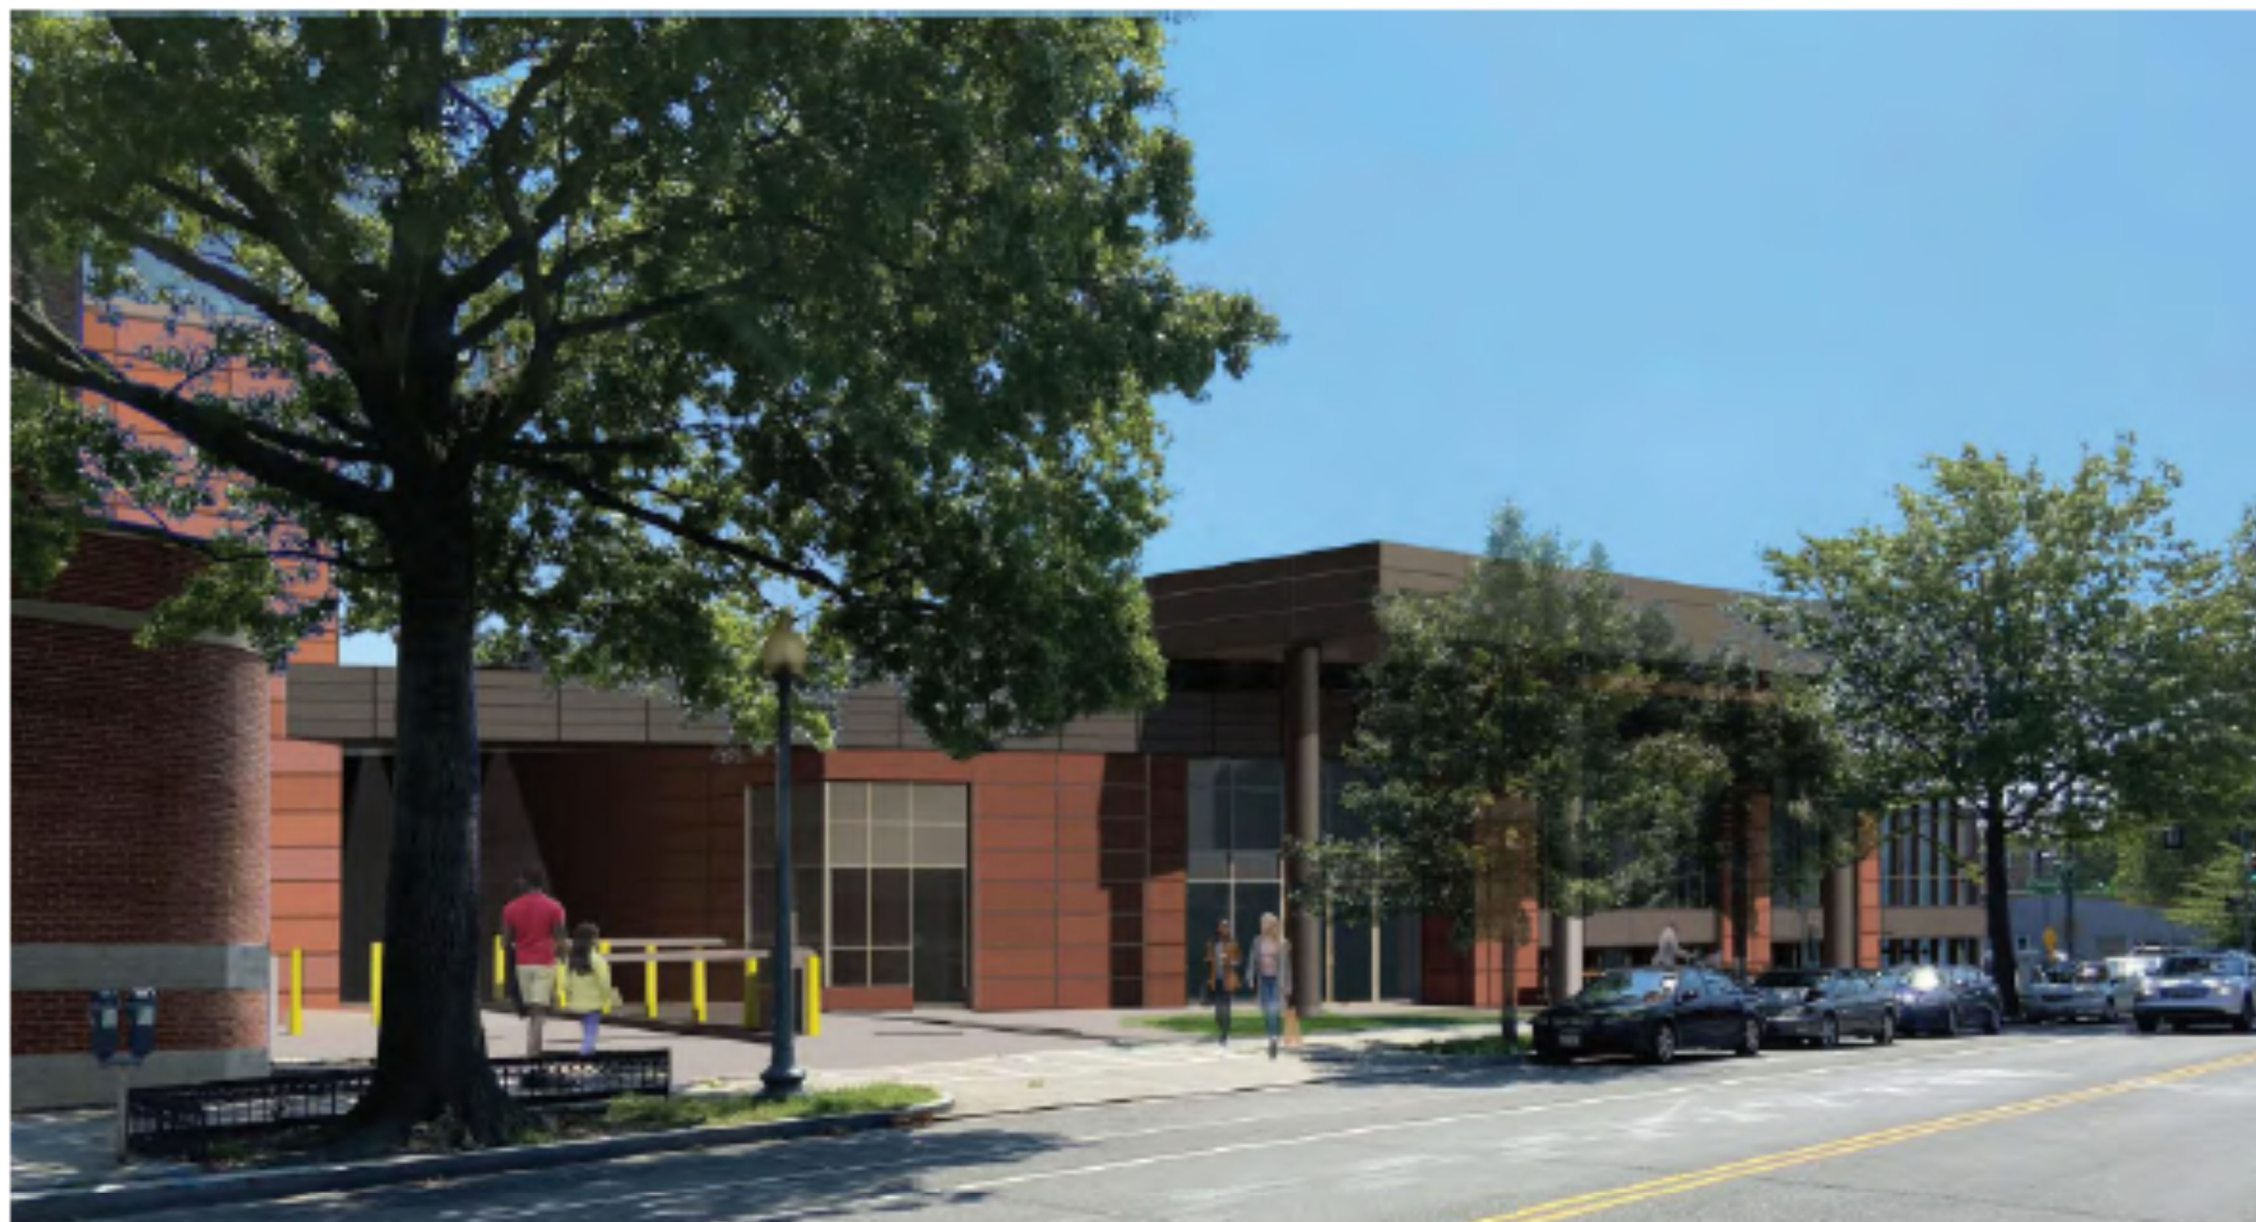
VIEW LOOKING SOUTHEAST ALONG 14TH STREET AT ENTRY

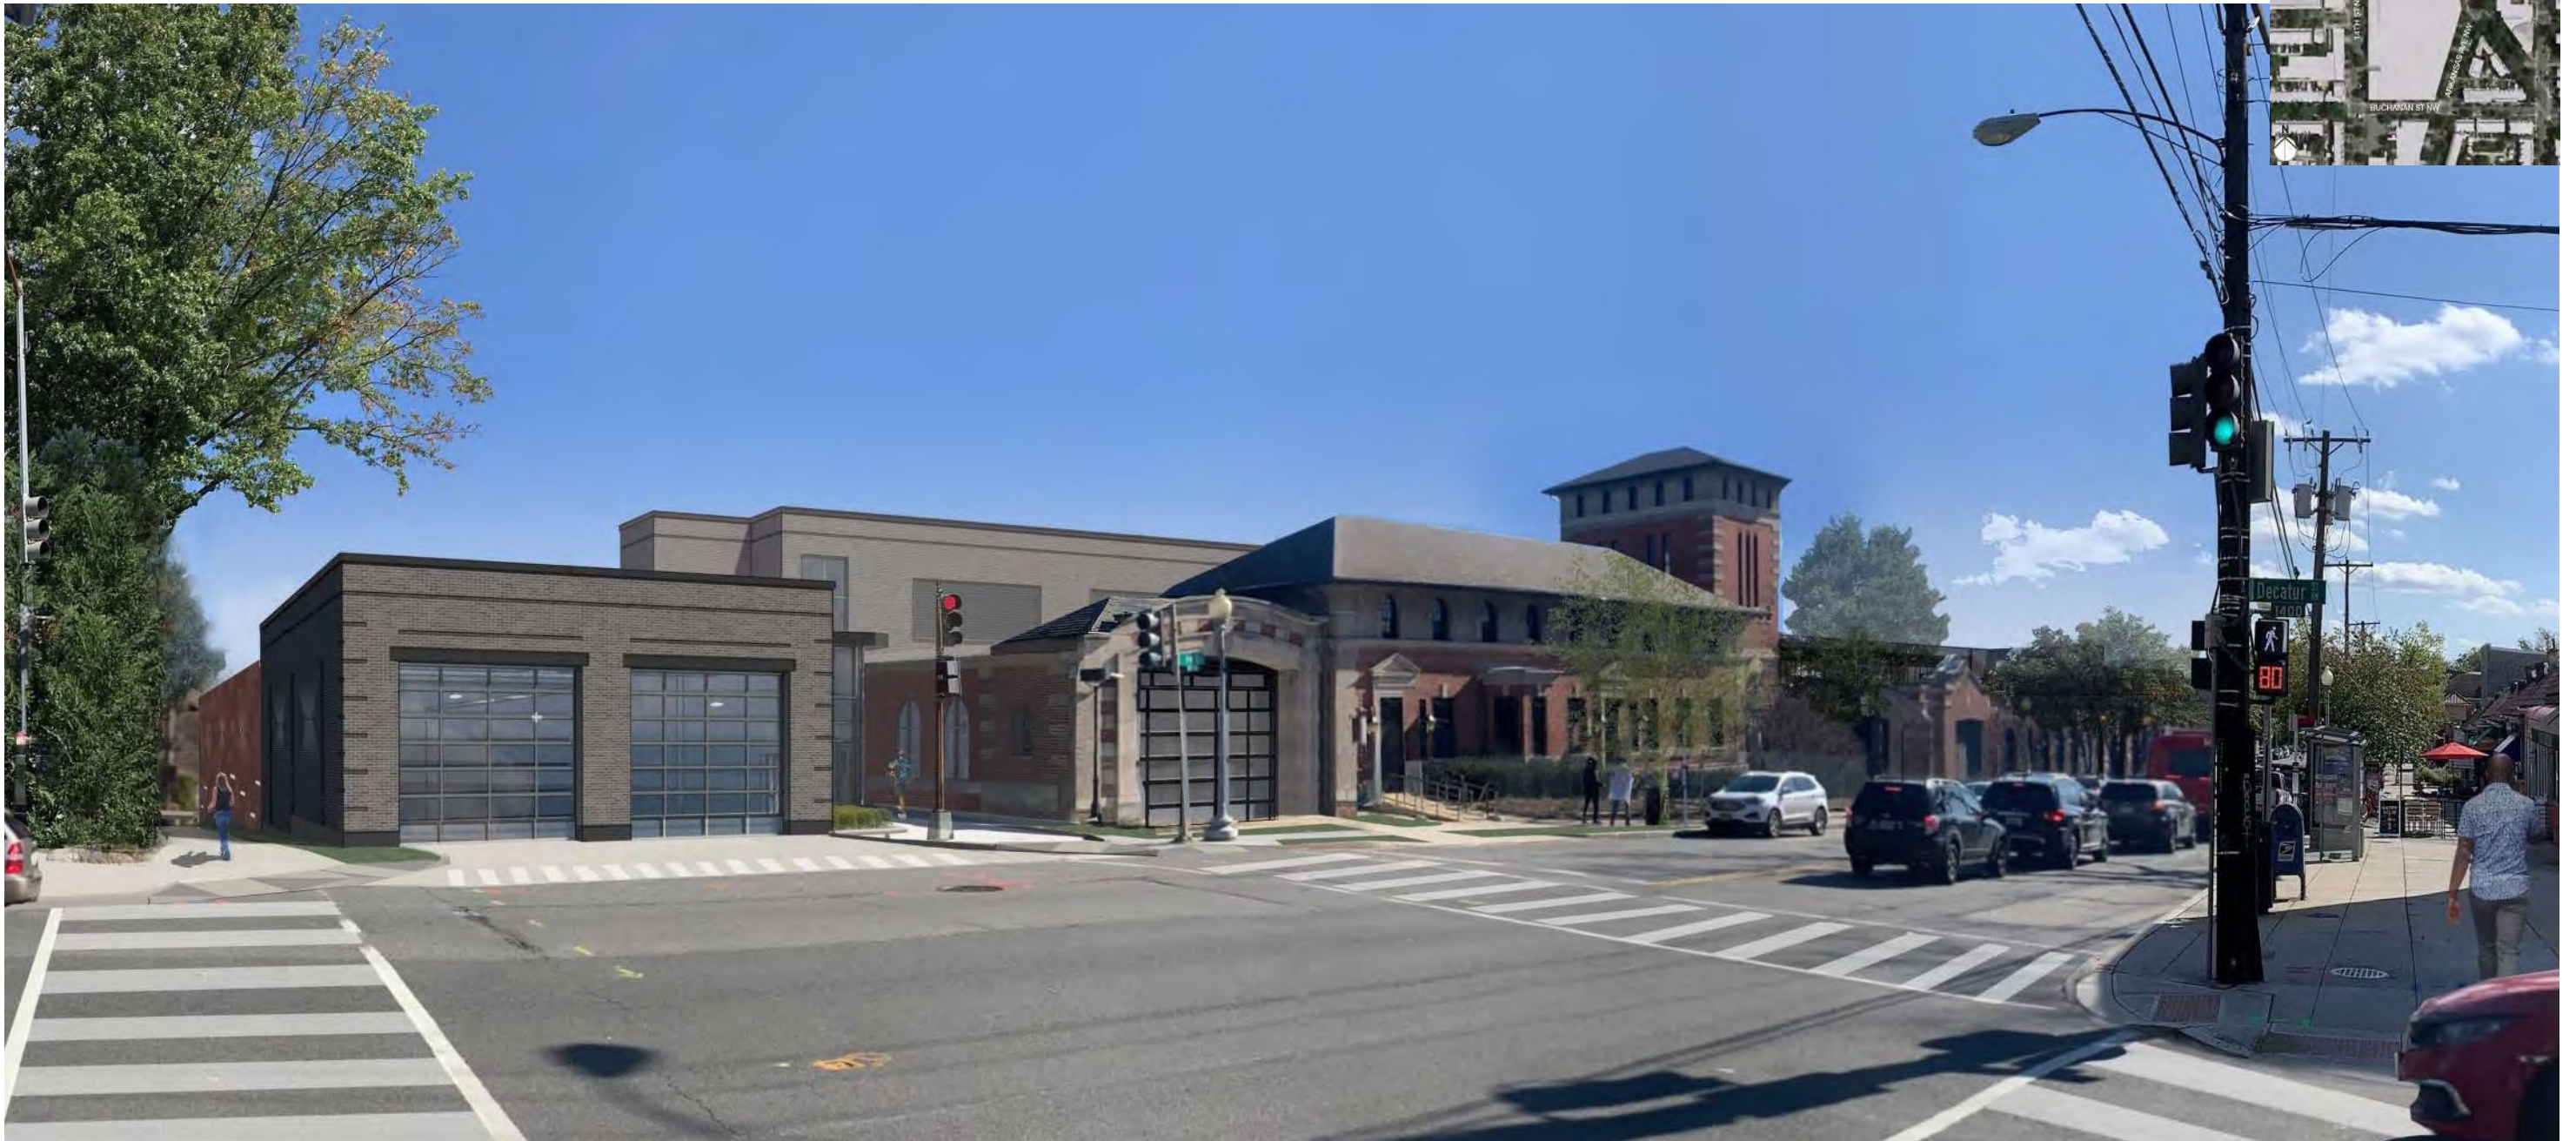
VIEW LOOKING SOUTHEAST ALONG 14TH STREET

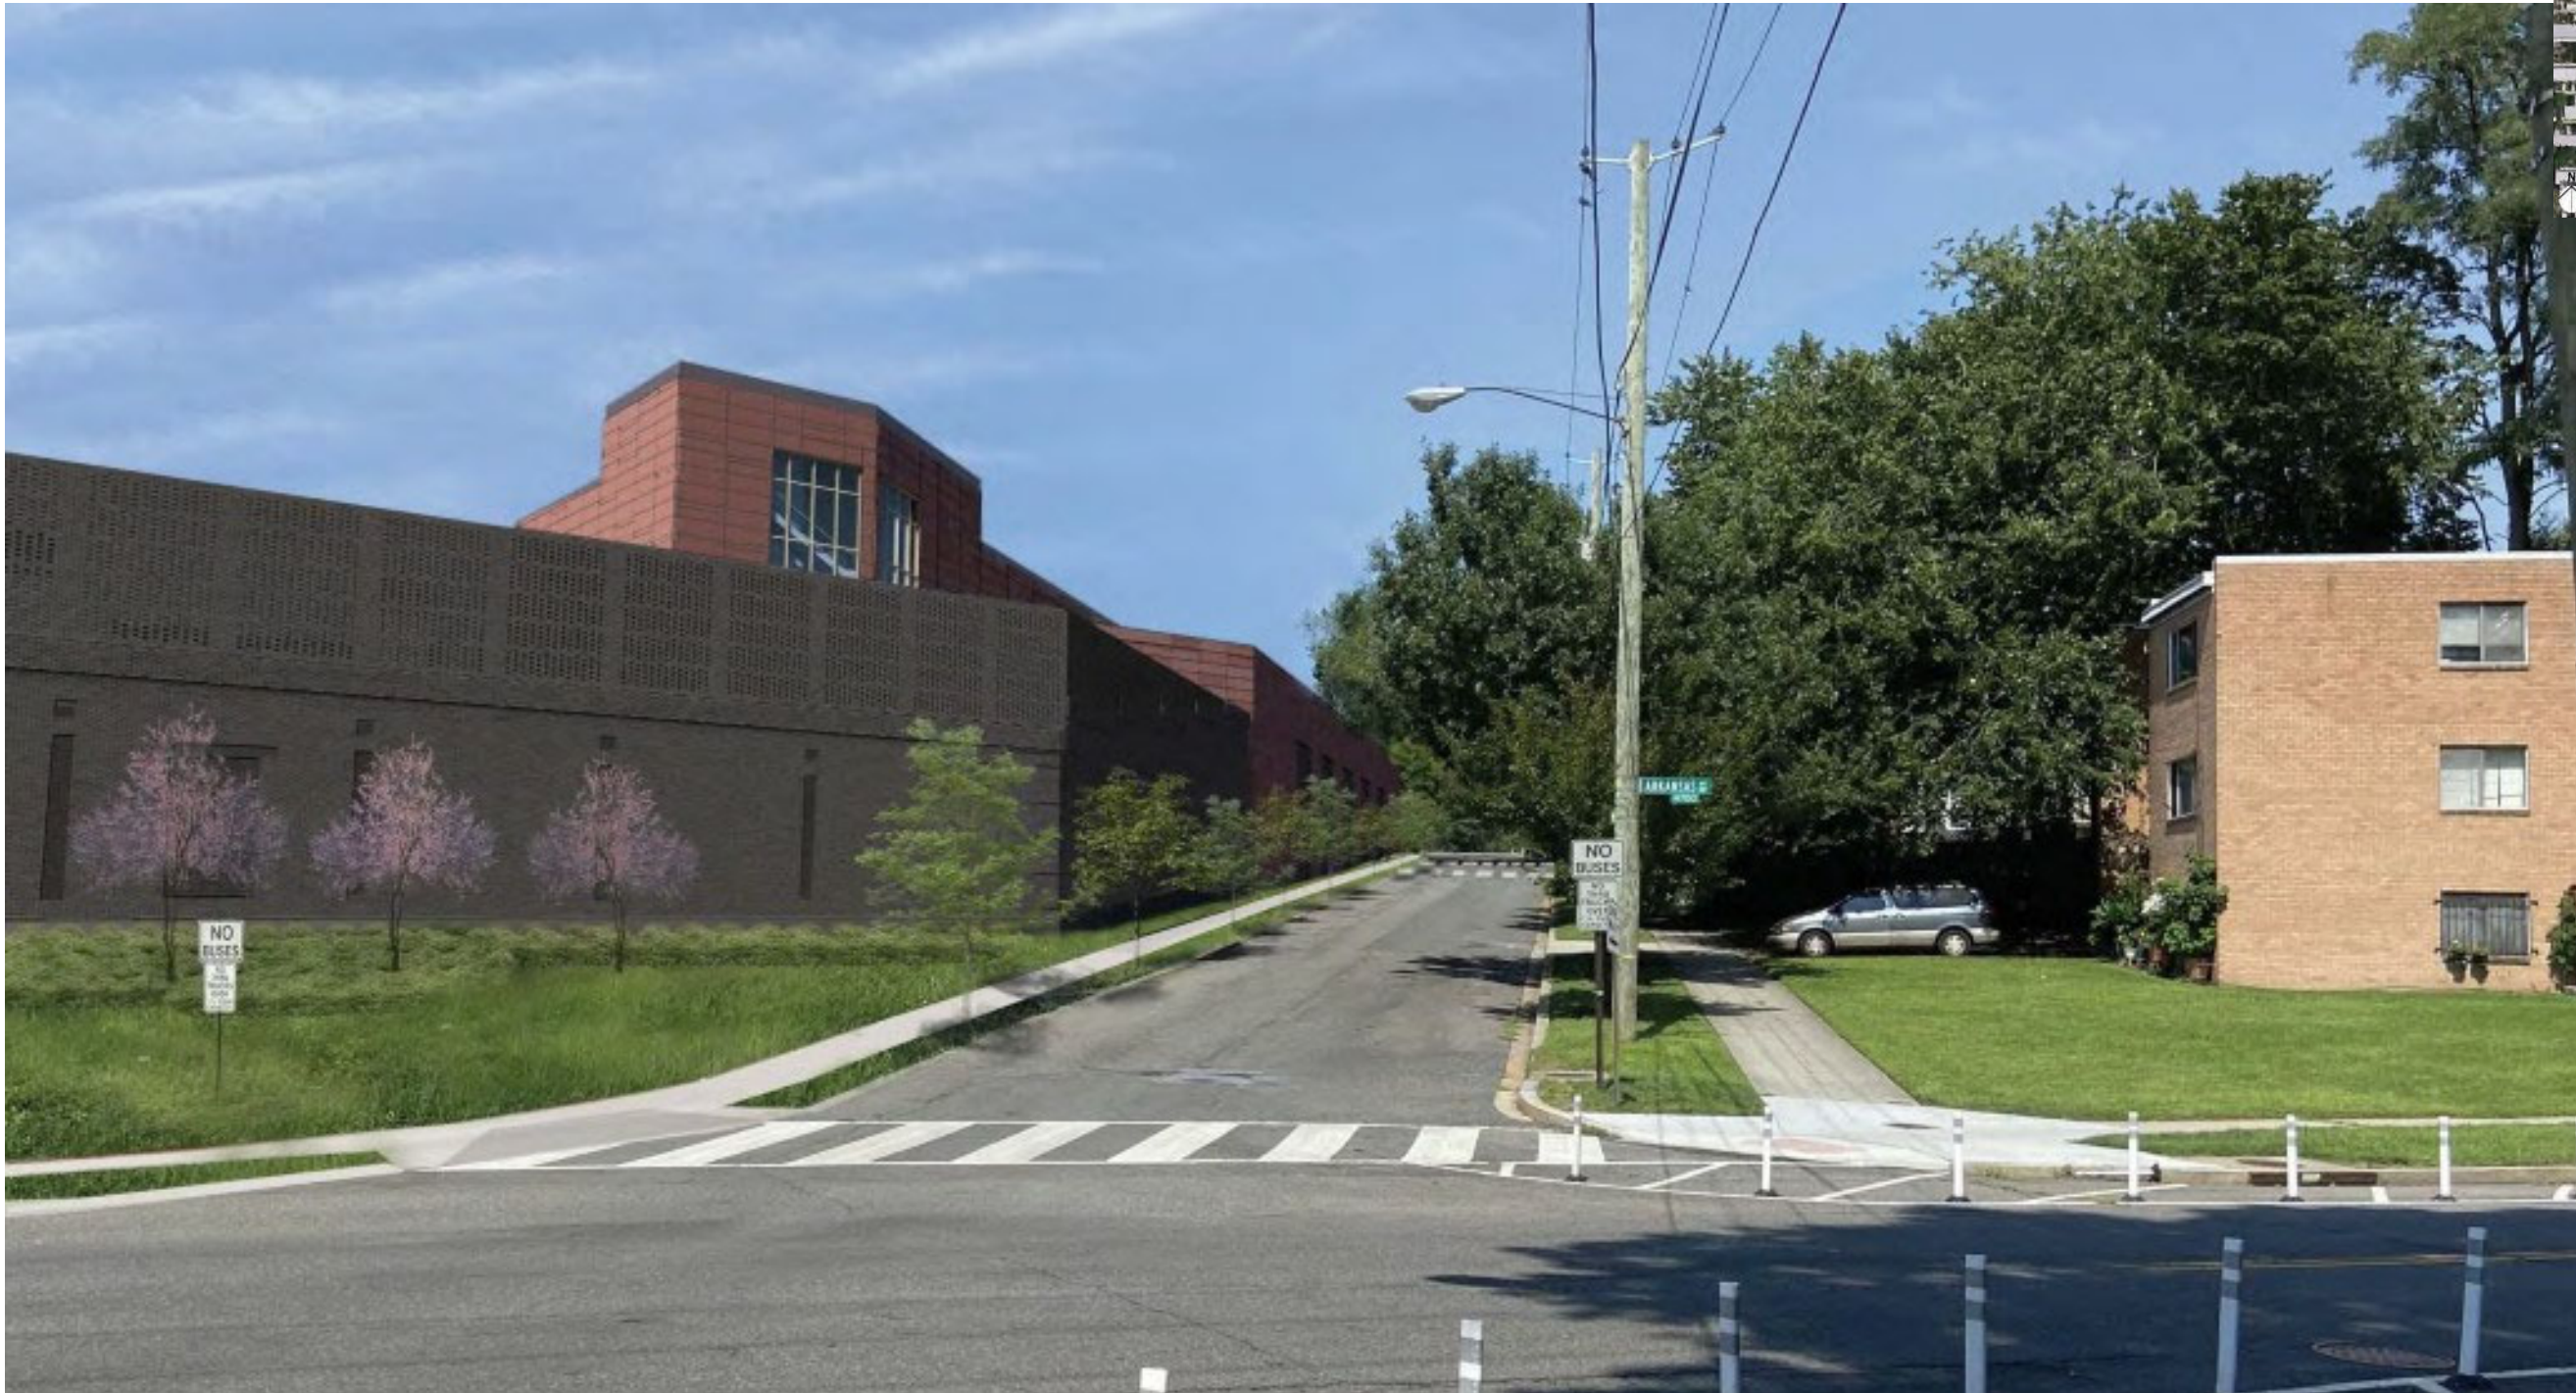
VIEW LOOKING NORTHWEST ALONG IOWA

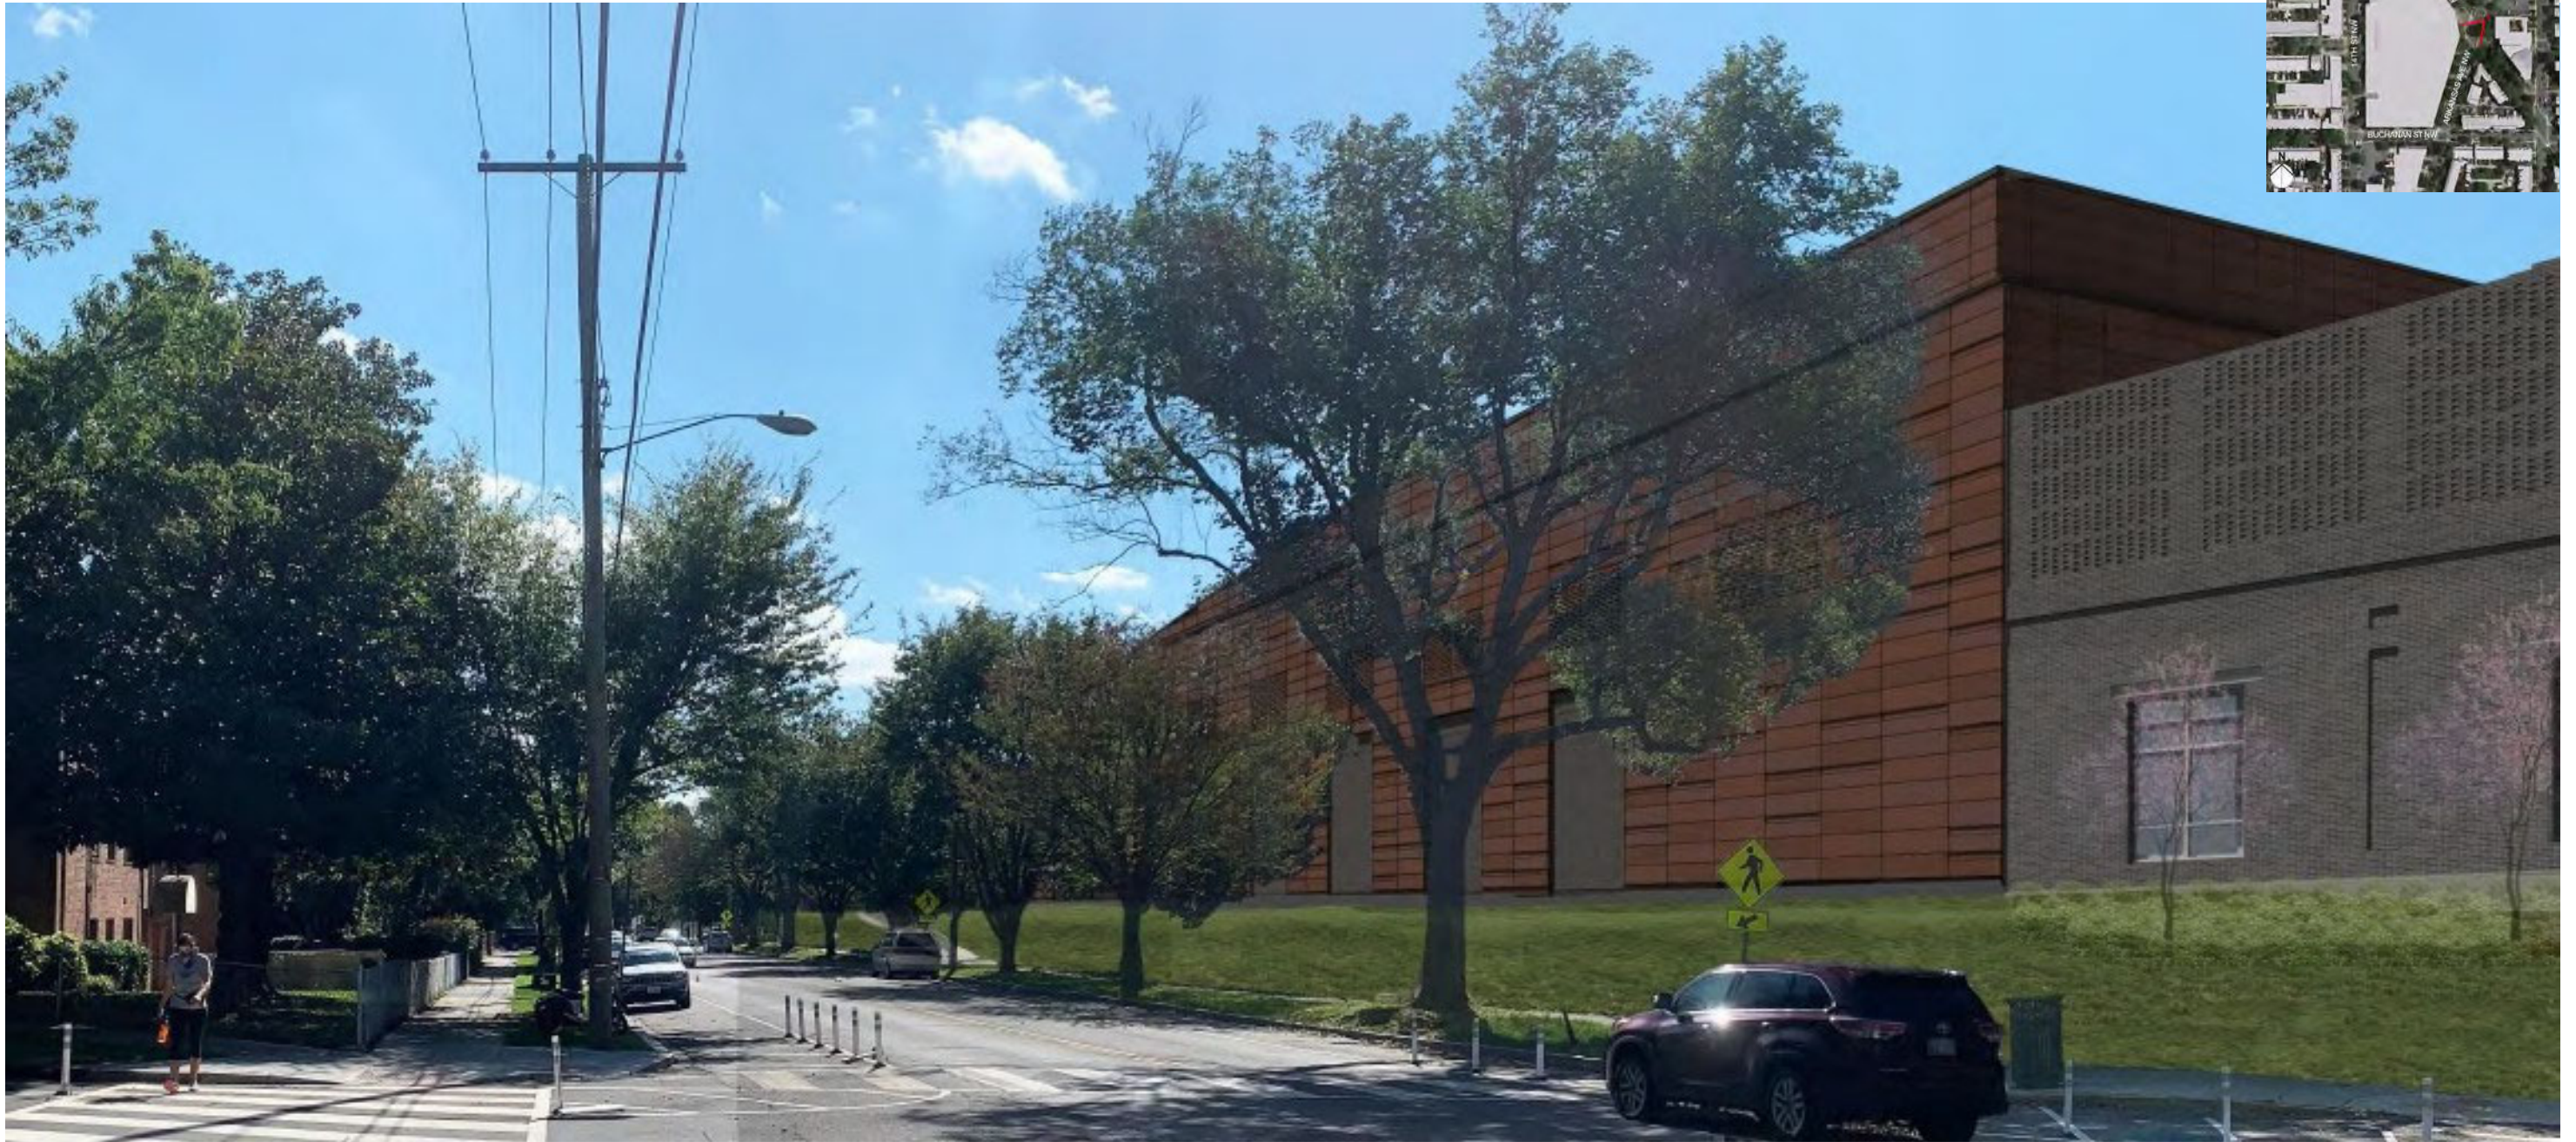
VIEW LOOKING SOUTHWEST ALONG ARKANSAS

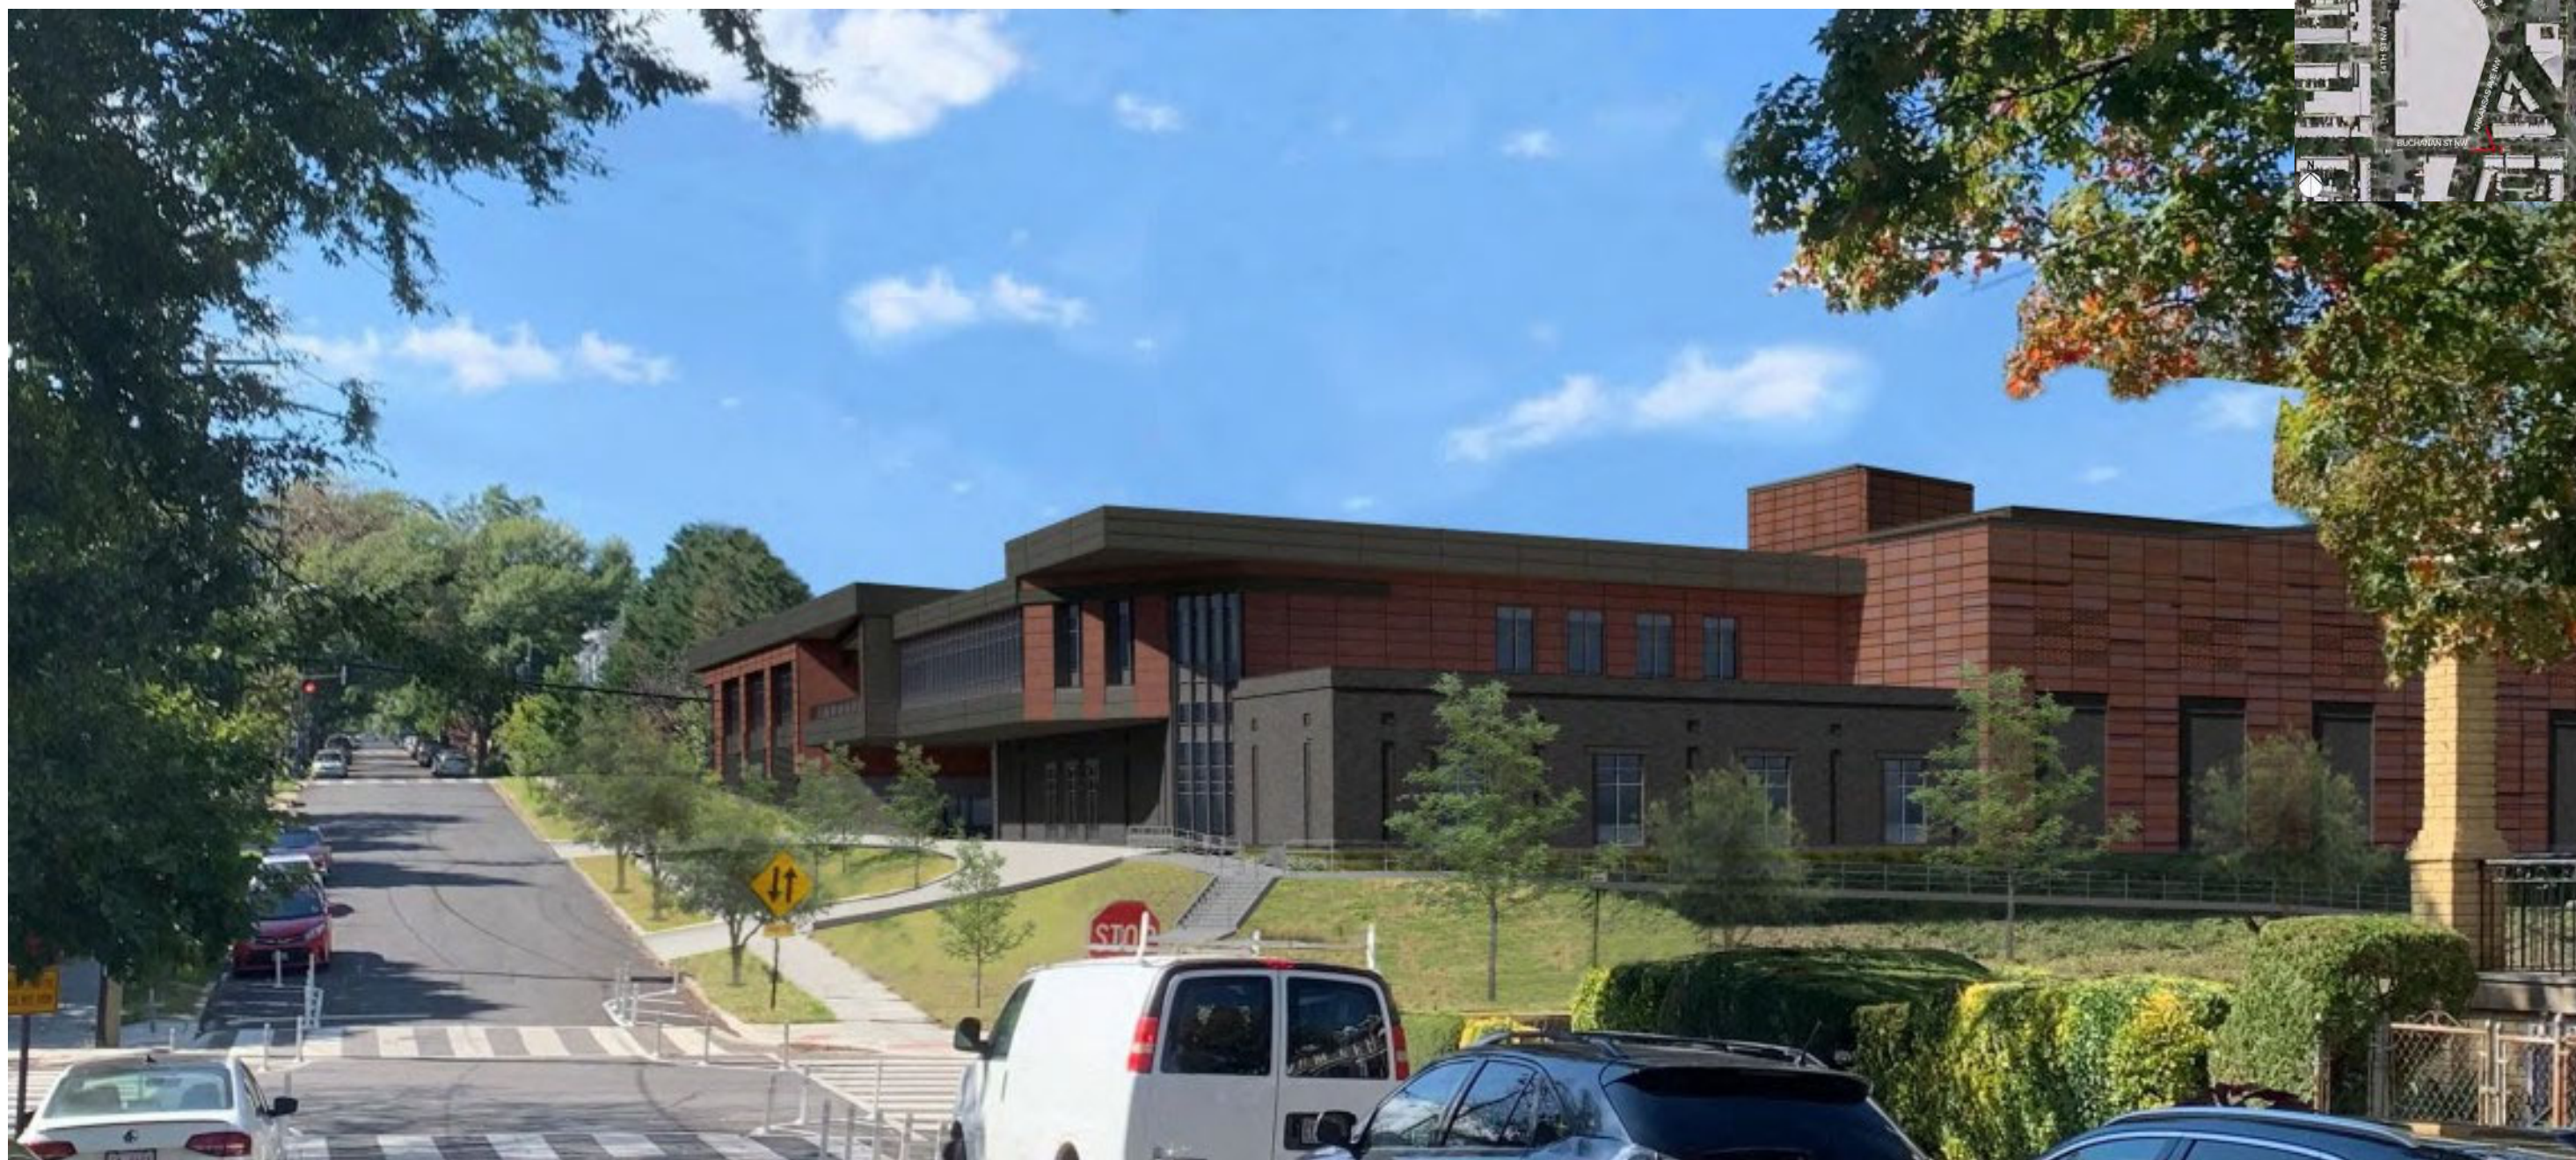
VIEW LOOKING WEST ALONG BUCHANAN AT SOUTHEAST CORNER

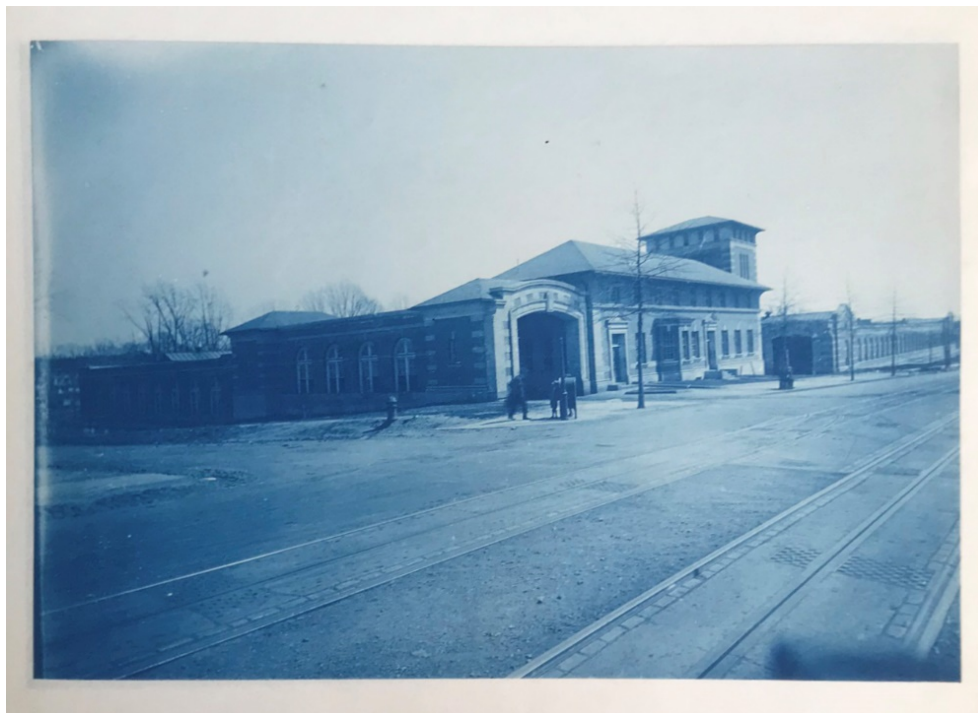
Figure 3. 1914 exterior photograph of the northwest corner of the streetcar barn showing the administrative offices, tower, and two of the three original streetcar openings. The north elevation features arched window openings and hipped roof pavilions at the center and western corner of the elevation (DC History Center)

The building was designed to look like two complementary masses: a two-story structure housing the administrative offices, featuring a hipped roof with overhanging eaves, and a two-story car barn and repair shop, characterized by a grand three-story tower with a clerestory. As designed and constructed, the garage consisted of an upper (main level) entered along 14th Street and a partially excavated lower (basement) level, accessed from the south elevation of the building. Exterior character-defining features included brick walls accented with stone belt courses, quoining, and keystones; shallow-pitched hipped roofs of the tower and administrative offices, and bracketed eaves. (See **Figure 3**) The garage and repair shop featured a flat roof with a front gable parapet and several large skylights. The building originally

featured three streetcar entrances and exits on the west façade: two facing west and framing the administrative offices and one facing north, immediately adjacent to the tower. Arched window openings on all elevations provided light to the garage and repair shop. The administrative offices, tower, and several projecting pavilions along the north and west elevations featured rectangular windows.

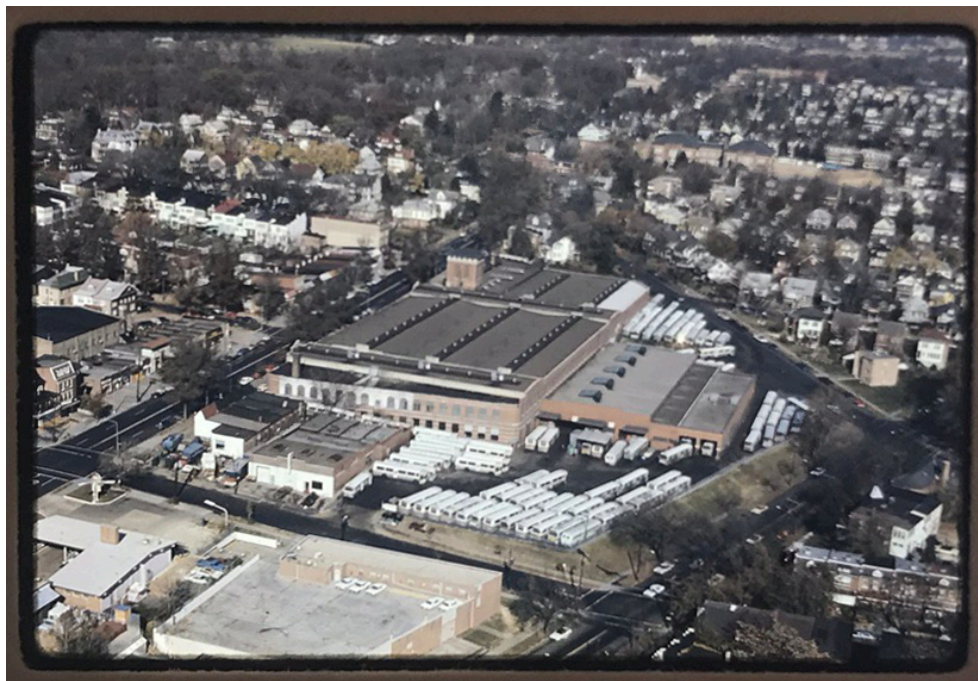
Figure 6. 1974 photograph of the bus garage looking northwest; the 1926 addition is visible on the right (WMATA Archive, George Washington University Special Collections)

In 1926, the Washington Rapid Transit Company, established in 1921, leased the lower level of the garage from the Capital Traction Company to use for buses. According to the NRHP nomination, a one-story addition was added to the east elevation of the building at this time to provide storage facilities for the buses. The addition is visible in the 1959 Sanborn map and a 1974 aerial photograph of the bus garage. (See **Figure 5** and **Figure 6**) It is possible that the 1926 addition was expanded after 1959, as it appears slightly larger in the 1974 photograph.

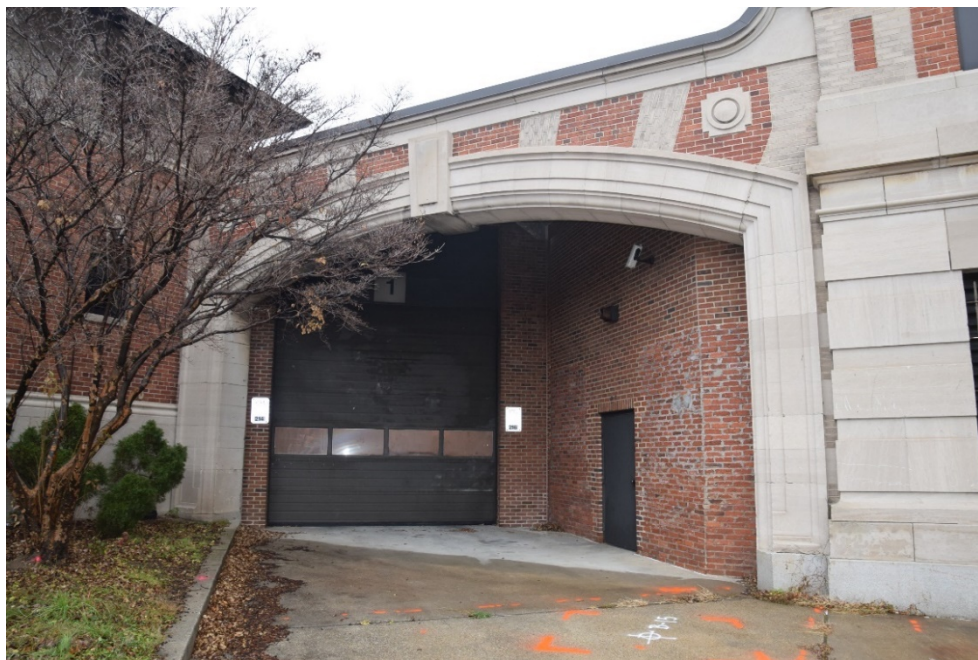
Figure 8. Angled brick wall on right constructed sometime after 1914 and prior to 1978. The wall created an additional interior room and enclosed the north elevation of the tower at that level. The other angled wall with the overhanging door was added after 1978 (BBB)

Another instance of unknown alteration occurred to the north of the tower. 1914 blueprints show that the north elevation of the tower adjacent to the streetcar opening was originally exposed, however, 1978 existing condition drawings show that an angled wall had been built at the streetcar opening, closing off the north elevation of the tower. Today, the wall is still extant, and a doorway has been inserted. (See **Figure 8**)

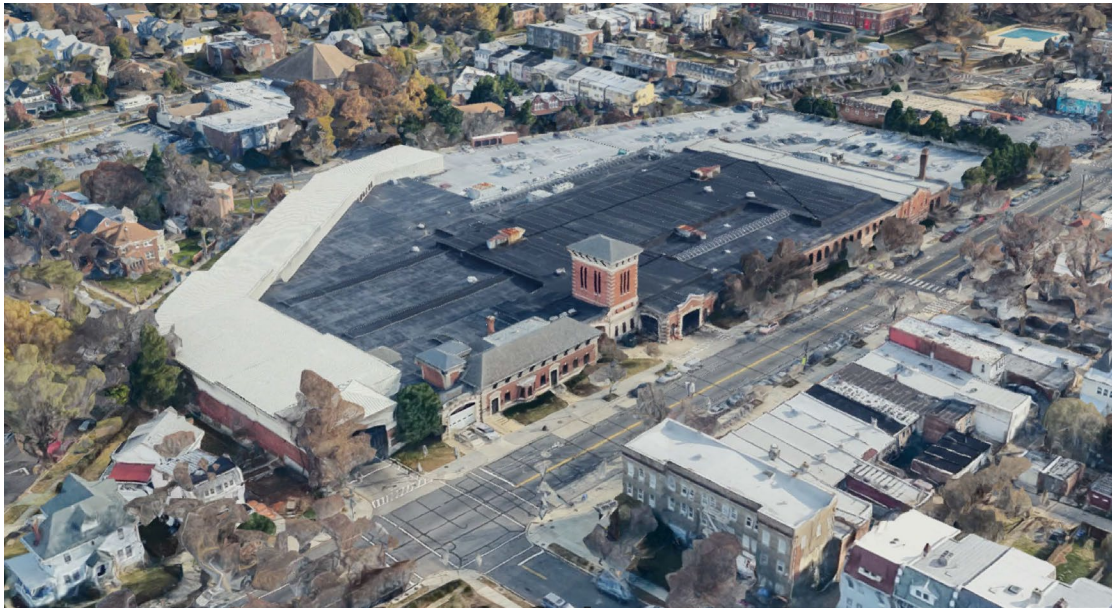
Figure 9. Contemporary aerial image of the bus garage looking southeast; the original bus garage was wrapped in the one-story 1987-1992 addition that enclosed Decatur Street to the left (north) of the administrative offices and provided WMATA with rooftop parking at the south and east (Google)

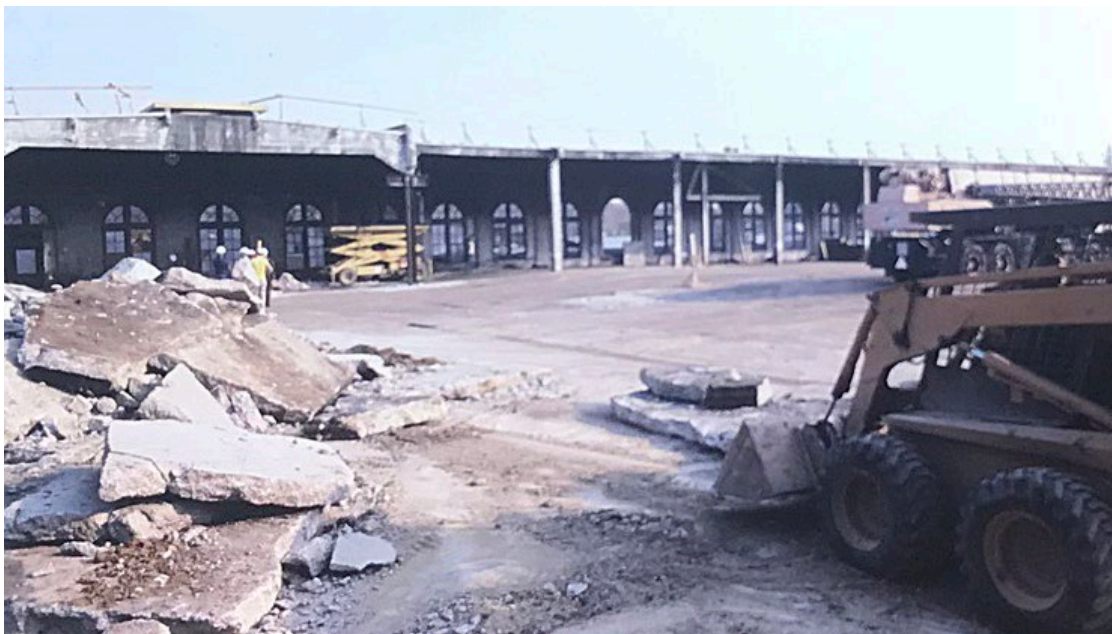
Figure 10. 1987 photograph looking east showing the extent of the demolition that occurred within the bus garage. The entire ceiling and roof structure in this area was removed except for one bay along the perimeter of the east wall (WMATA Archive, George Washington University Special Collections)
